Assessment Supplement

Appendix to 'CSHBA – Stewardship of Chinatown Society Buildings'

Chinatown Society Heritage Buildings Association

Prepared By
Dunefield

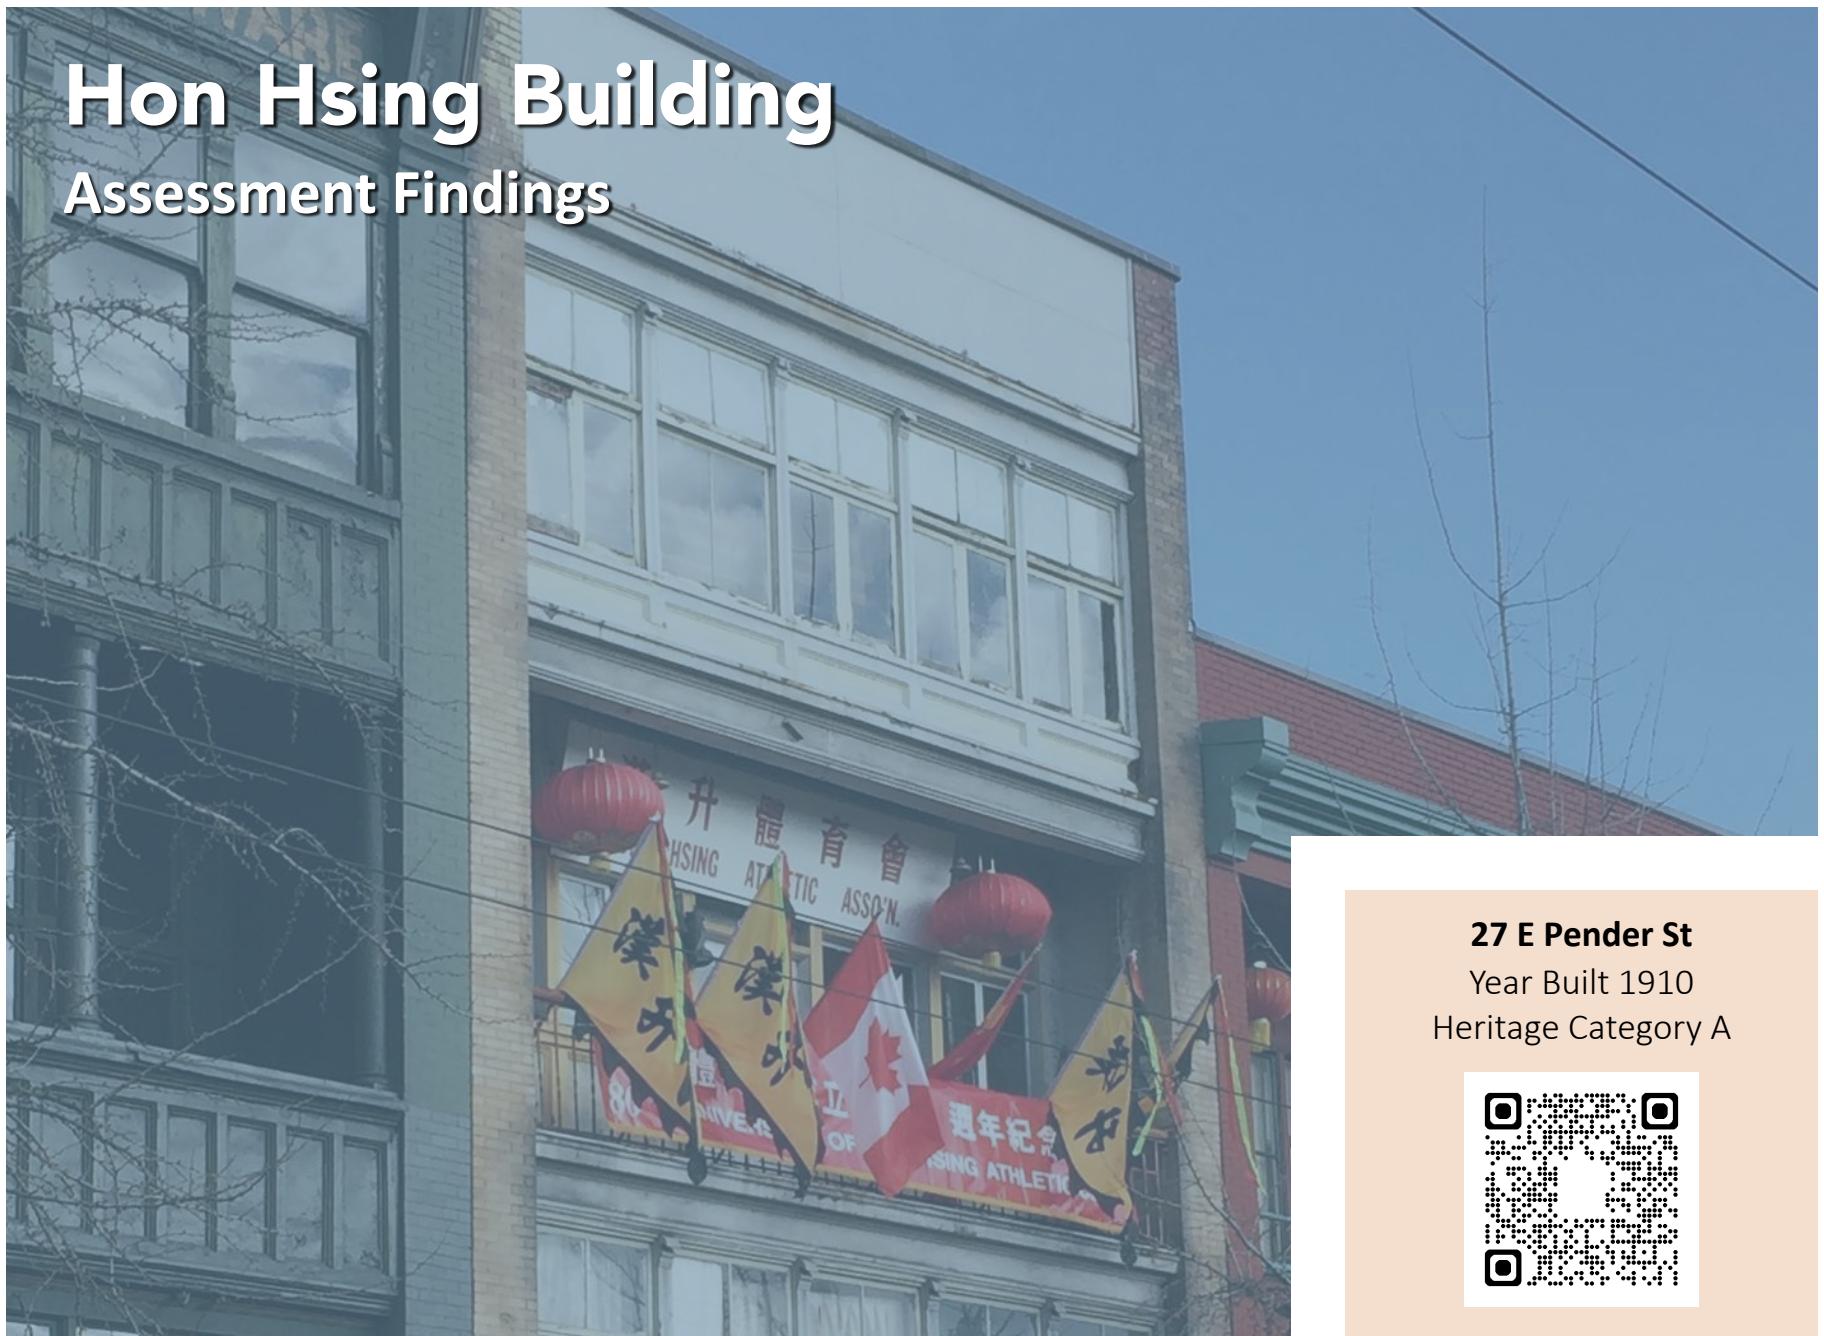
- Basement **50kVA transformer** is positioned where it's at risk of flooding and moisture (A)
- **Carbon monoxide detectors** must be installed where gas-fired heating is used
- **Grandfathered SRAs** on second floor are non-compliant and need to be phased out (B)
- **Gas-fired equipment** for cooking and hot water is very old and needs to be replaced (C)

- **Rear wall** has open grout joints, risking partial collapse into the laneway (D), and some downpipe mounts have failed
- **Cinder blocks** of rear wall contain asbestos-contaminated vermiculite, and should be monitored for leaks and can only be disturbed by a qualified professional (E)
- **Heating system** needs to be inspected, and repaired or replaced, to allow the society to regulate interior conditions, prolonging the lifespan of the building (F)
- **Plumbing leaks** have previously caused rot on the superstructure, and a kitchen and bathroom plumbing inspection is needed (G)

- **Basement** is unfinished and lacks protection from flooding (e.g. back-up pump or alarm system) and moisture ingress—it could be upgraded to add usability to the space (H)
- **Second floor** could be improved with minor repairs, repainting where needed, life and safety improvements and accessibility features, all in support of its future use

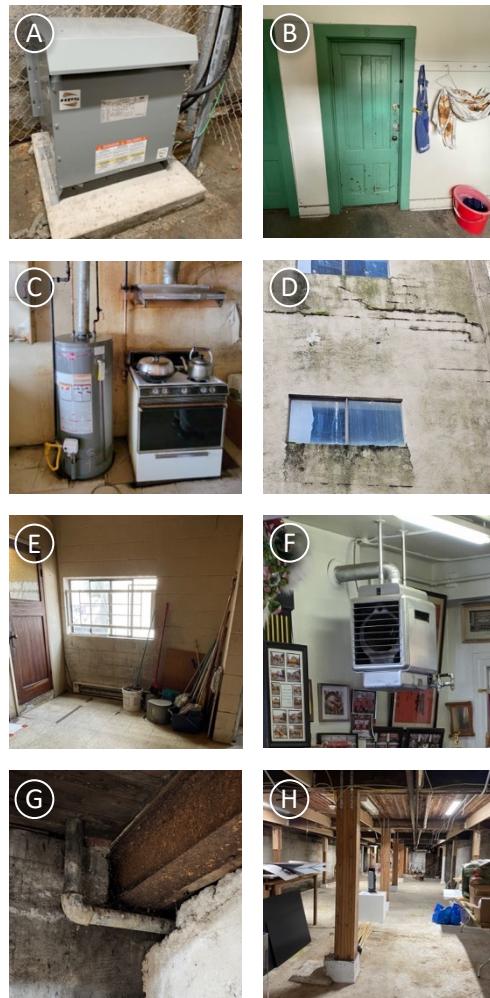
- **Fluorescent fixtures** are outdated, present a potential fire risk, and need replacement

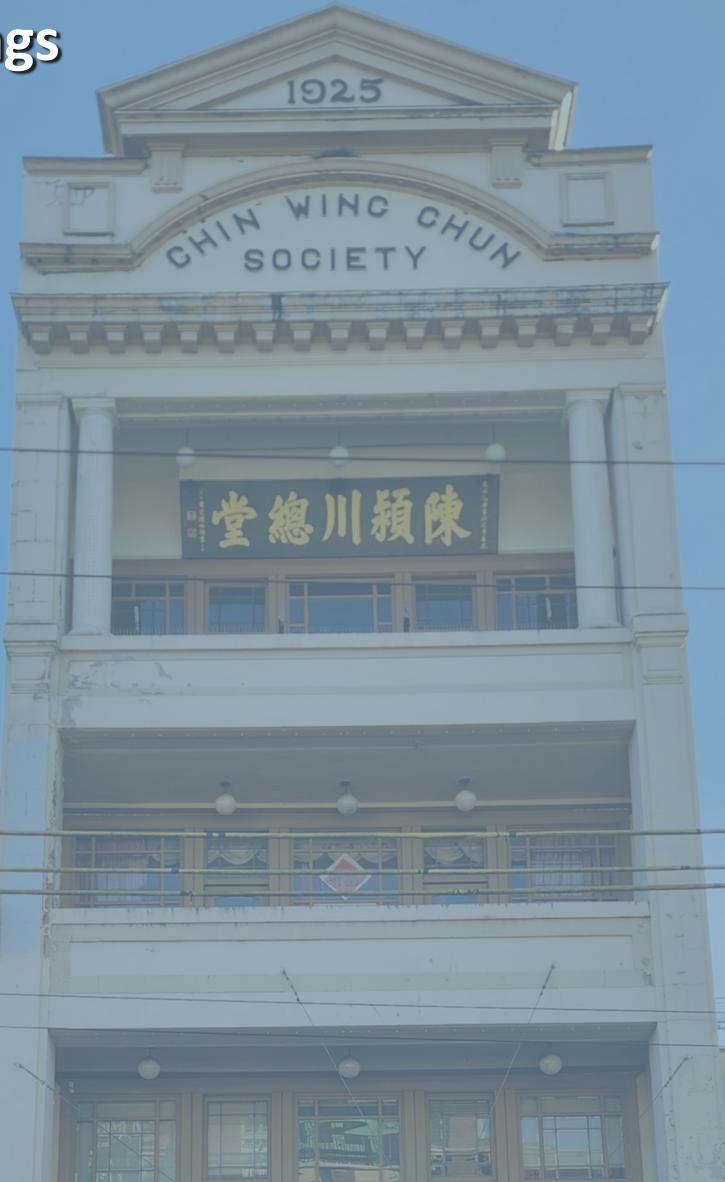
- Lane **exterior fire escape** is in poor condition and needs repairs to ensure safety (A)
- **East wall** is out of plumb and bulging on the inside, with unknown conditions that are concealed, including by recent paint (B)
- Same wall shows signs of **moisture ingress** and other conditions that may be related (or contributing) to the structural threat (C)
- **Roof membrane** appears to be new but was improperly installed and seams are failing (D)
- The **glass dome** is close to collapse, and must be removed urgently and rebuilt later (E)
- The rear wall's **masonry veneer** is leaning outward and needs to be repaired and stabilized before it collapses (F)
- **Carbon monoxide detectors** must be installed where gas-fired heating is used

- **Structural integrity** requires full assessment to understand source of various conditions
- **Heating system** needs to be inspected, and repaired or replaced, to control interior conditions and prolong building lifespan
- **Electrical distribution system** on upper floors has been upgraded, while older parts need retrofit during tenant improvements
- Inner **balcony walls** (east side) show signs of moisture ingress and unusual growth (G)
- **Fluorescent fixtures** are outdated, present a potential fire risk, and need replacement

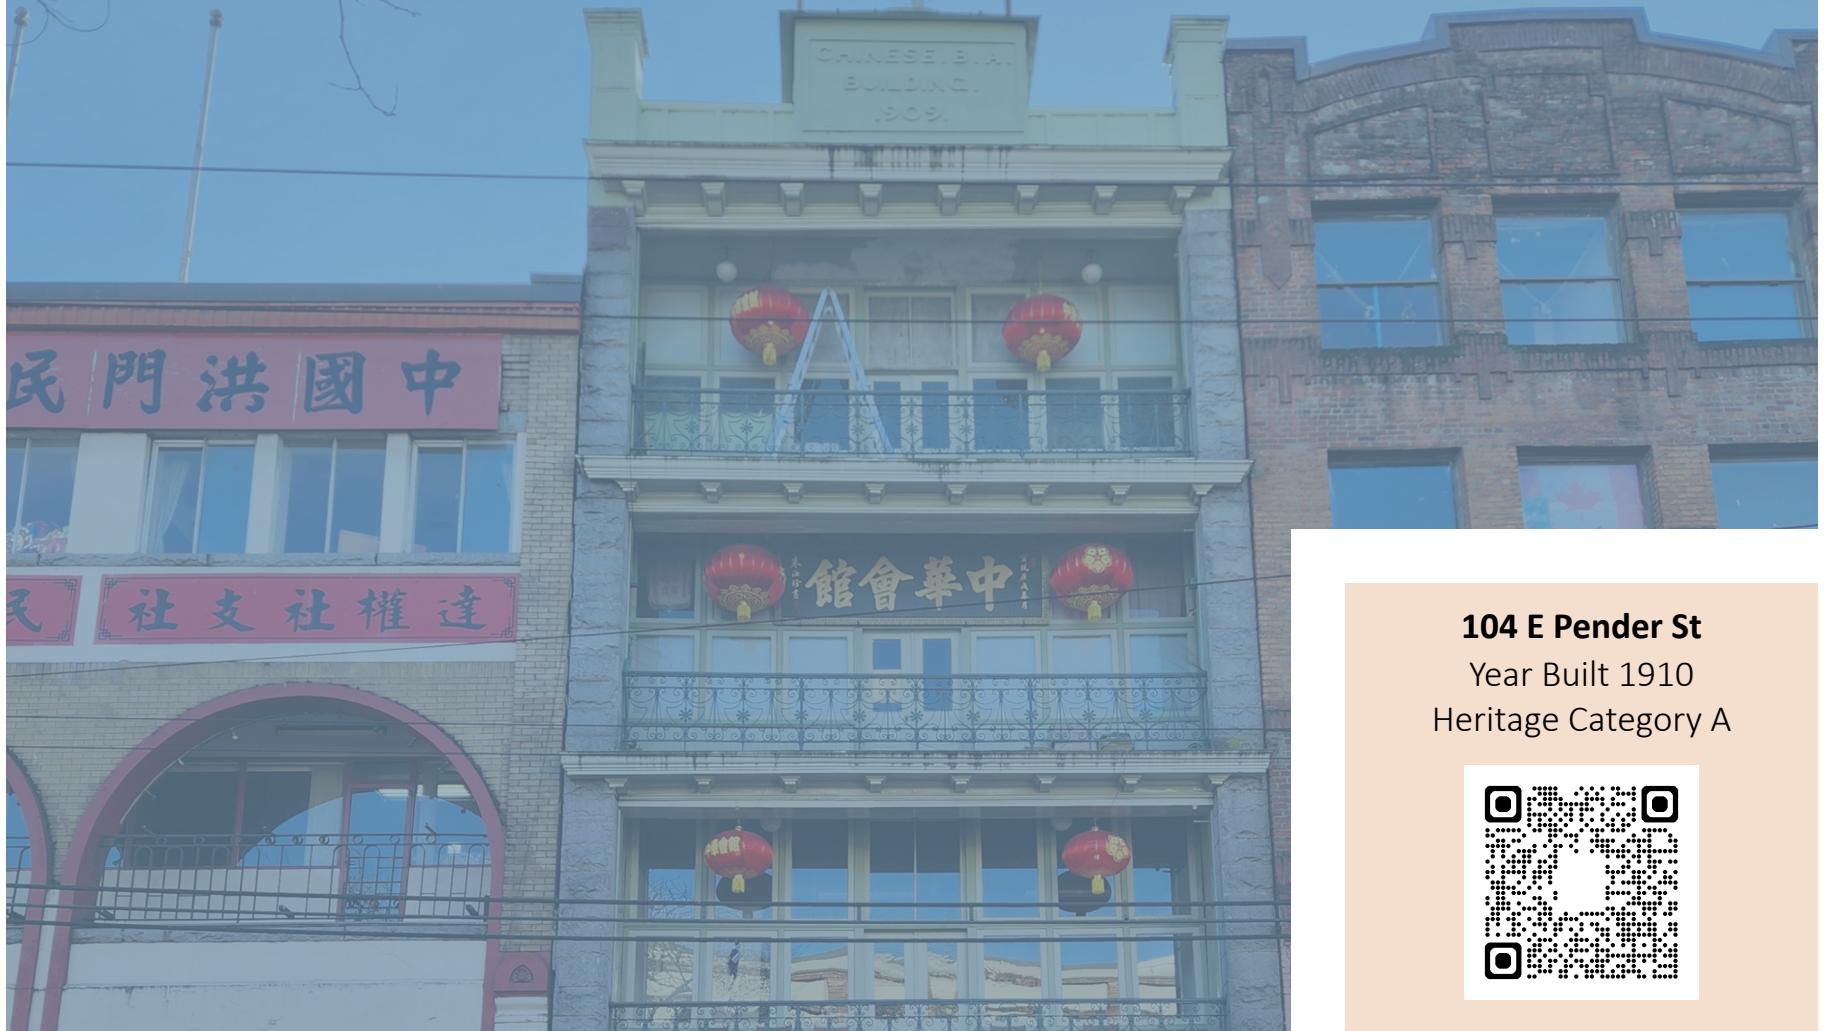
- Lane **exterior fire escape** misses the low-rise segment and no longer allows safe exiting (A)
- **Roof membrane** is a stack of old layers, and leaks, soft spots and rotting need repairs (B)
- A single **roof drain** is inadequate and water is spilling over the roof lip during heavy rain (C)
- **Carbon monoxide detectors** must be installed where gas-fired heating is used

- **Rear wall** (at ground level, 1-story portion) appears to be bulging out, and needs closer inspection to confirm its stability (E)
- **Heating system** needs to be inspected, and repaired or replaced, to regulate interior conditions and prolong building lifespan
- **Electrical distribution system** is very old, and needs closer inspection and retrofit (F)
- **Fluorescent fixtures** are outdated, present a potential fire risk, and need replacement
- All **covered balconies** have built-up decks that conceal failed (rotten) assemblies (G)
- **Flooding and leaks** affect the basement and and retail store, causing mold and rot

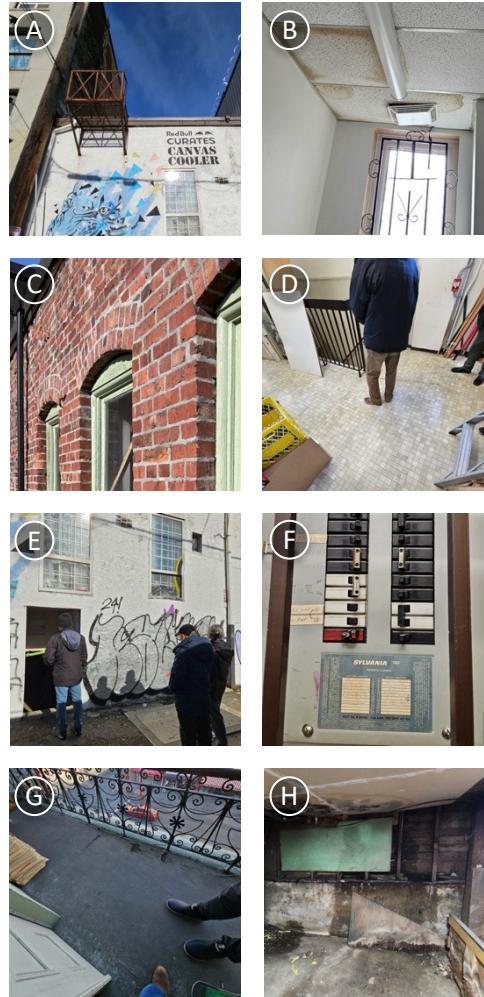
- Floors near stair landings are **deflecting and sagging**, and require structural review (D)

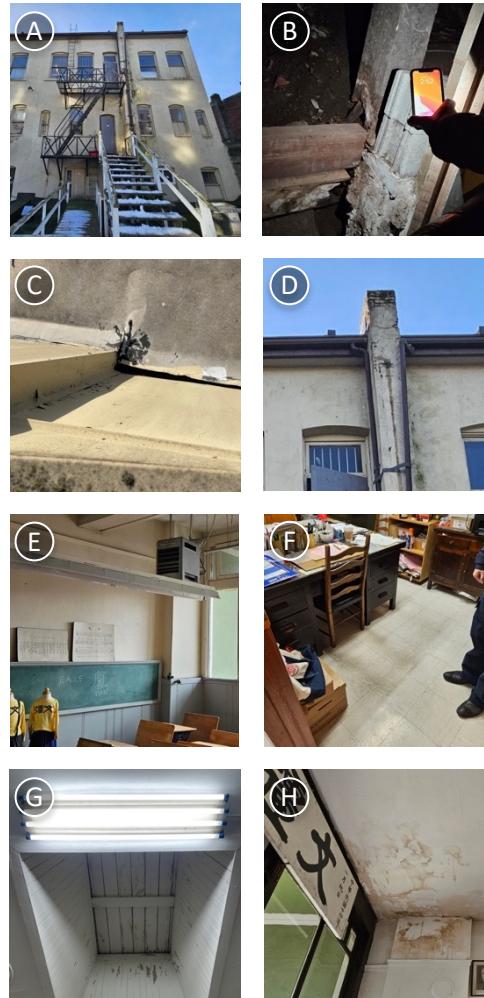
- Lane **exterior fire escape** sits on framing that is at risk of collapsing and needs urgent repairs, including wall envelope, ground floor landings, and door hardware (A)
- **Foundation** exhibits structural distress and damage, and requires full review for repairs to joists, beams and columns in the basement, extending up to the first floor (B)
- **Roof damage** and holes need repairs, including chimney caps, cornice flashings and covered skylights, to protect the building from further water damage (C)
- **Roof draining** is insufficient and additional drainage must be retrofitted to reduce risk of clogs, damage, spillage, etc. (D)
- **Carbon monoxide detectors** must be installed where gas-fired heating is used (E)

- Floors are **deflecting and sagging**, most noticeably at the 2nd floor, and require structural review, monitoring and repairs (F)
- **Fluorescent fixtures** are outdated, present a potential fire risk, and need replacement (G)
- **HVAC system** needs to be installed to control conditions in the archive for artifacts
- **Wall conditions** must be inspected and repaired to improve weather resistance (H)
